**A SEMI-ANNUAL AQUATIC MONITORING REPORT FOR A  
SURFACE MINE PERMIT (DMLR # 1101760) LOCATED NEAR  
ROARING FORK IN WISE COUNTY, VIRGINIA**

**Prepared for:  
Red River Coal Company, Inc**

**ATS PROJECT NO. 1199.01**

**July 2013**

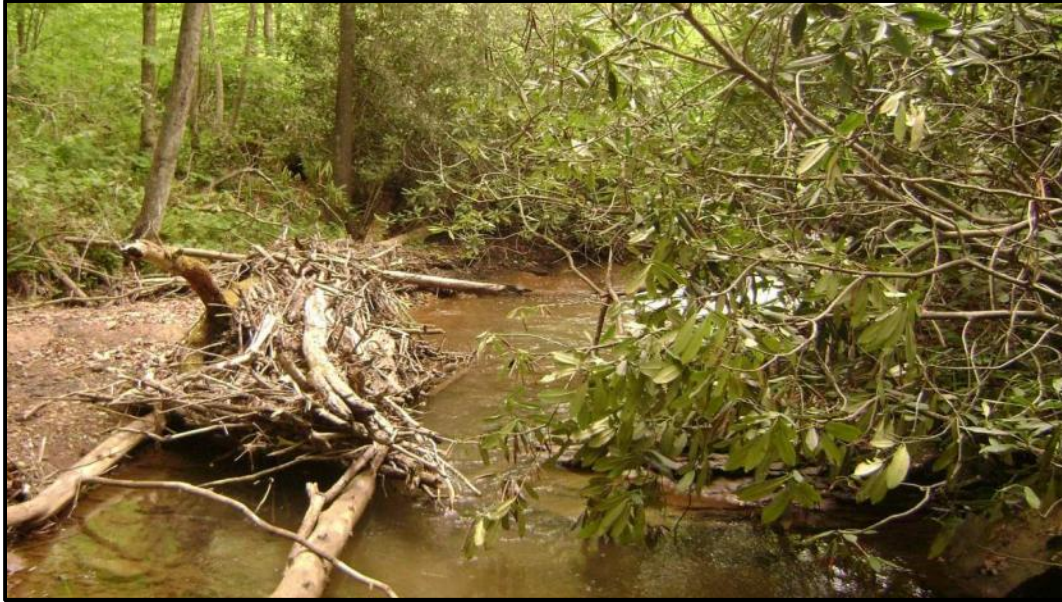
**Figure 2: BRFK-1 upstream view**

The stream habitat at BRFK-1 scored 141 of 200 (Appendix A), indicating the habitat is partially supporting its designated use. The stream was approximately 15 feet wide and characterized mostly by a series of riffles and runs (Figures 2 and 3). Flow occupied >75% of the stream channel. Embeddedness was suboptimal with approximately 25 to 50% of the substrate particles surrounded by fine sediment. The water was clear but there was slight deposition of sediment within the streambed. The stream banks were moderately stable and with good riparian zones.

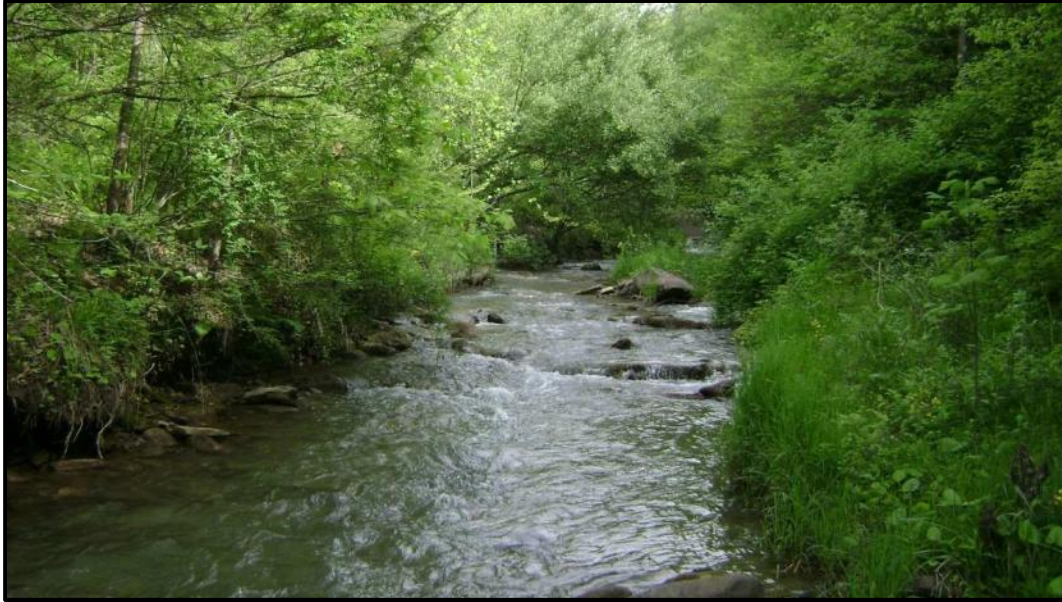
**Figure 4: BRFK-2 upstream view**

The stream habitat at BRFK-2 scored 129 of 200 (Appendix A), indicating the habitat is partially supporting its designated use. The stream was approximately 15 feet wide and characterized mostly by a series of riffles and runs (Figures 4 and 5). Flow occupied >75% of the stream channel. Embeddedness was suboptimal with 25 to 50% of the substrate particles surrounded by fine sediment. The water was clear but there was slight to moderate deposition of sediment within the streambed. The stream banks were moderately stable but the right bank had a narrow riparian zone.

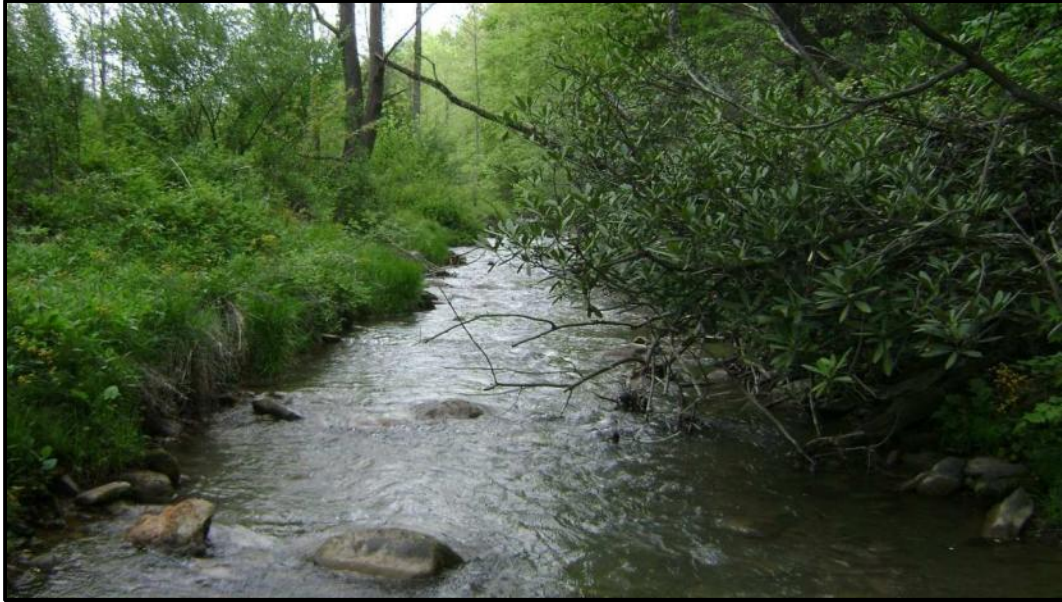
**Figure 6: BRFK-3 upstream view**

The stream habitat at BRFK-3 scored 130 of 200 (Appendix A), indicating the habitat is partially supporting its designated use. The stream was approximately 15 feet wide and characterized mostly by a series of riffles and runs (Figures 6 and 7). Flow occupied >75% of the stream channel. Embeddedness was suboptimal with 25 to 50% of the substrate particles surrounded by fine sediment. The coloration of the water was clear and there was slight to moderate deposition of sediment within the streambed. The stream banks were moderately stable but the right bank had a narrow riparian zone.

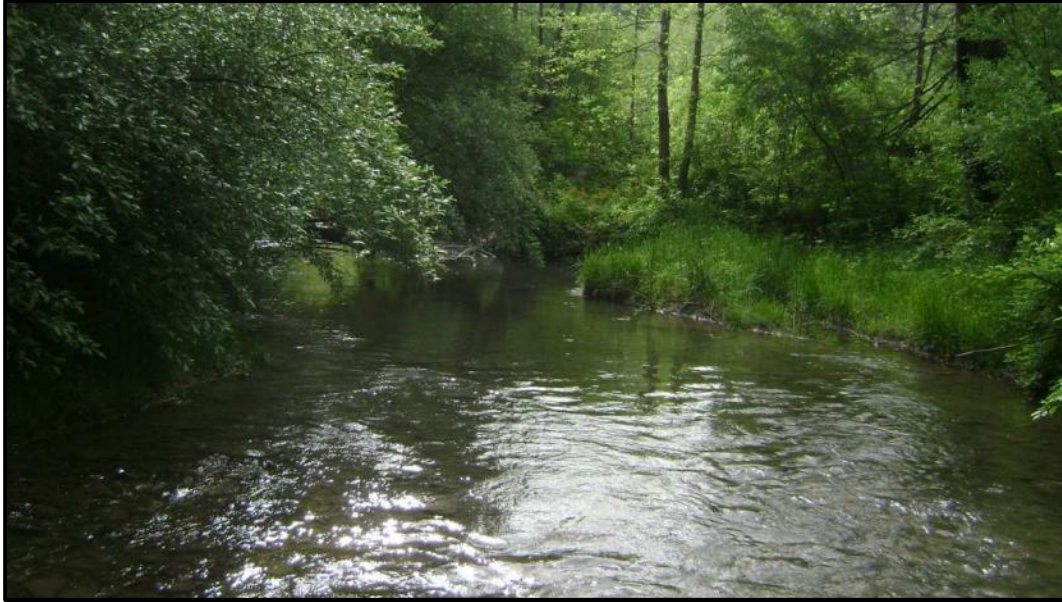
**Figure 8: BRFK-4 upstream view**

The stream habitat at BRFK-4 scored 137 of 200 (Appendix A), indicating the habitat is partially supporting its designated use. The stream was approximately 15 feet wide and characterized mostly by a series of riffles and runs (Figures 8 and 9). Flow

occupied >75% of the stream channel. Embeddedness was suboptimal with approximately 25 to 50% of the substrate particles surrounded by fine sediment. The coloration of the water was clear but there was evidence of slight to moderate sedimentation within the streambed. Both stream banks were stable and good with riparian zones.

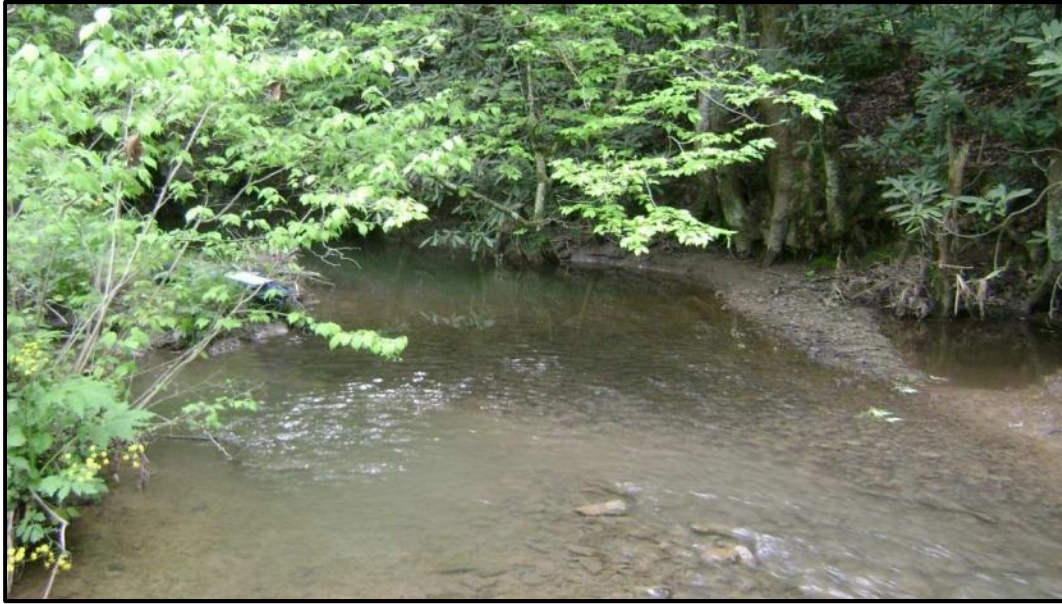
**Figure 10: BCPT-1 upstream view**

The stream habitat at BCPT-1 scored 125 of 200 (Appendix A), indicating the habitat is partially supporting its designated use. The stream was approximately 12 feet wide and characterized mostly by a series of riffles and runs (Figures 10 and 11). Flow occupied >75% of the stream channel. Embeddedness was suboptimal with 25 to 50% of the substrate particles surrounded by fine sediment. The coloration of the water was clear but there was evidence of moderate sedimentation within the streambed. The stream banks were somewhat stable but the right bank had a narrow riparian zone.

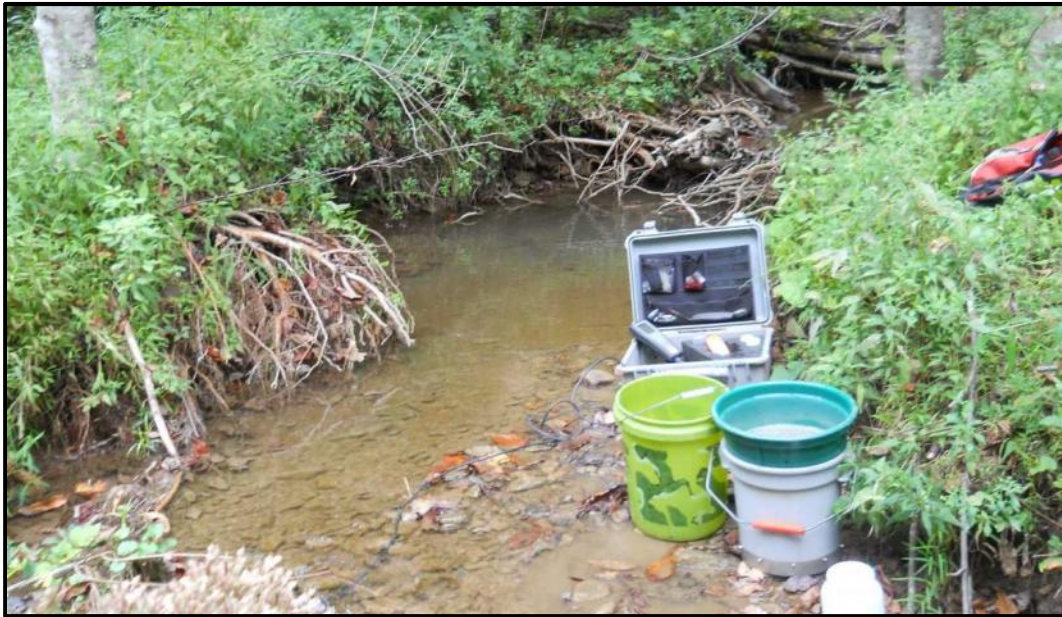
**Figure 12: BPR-1 upstream view**

The stream habitat at BPR-1 scored 133 of 200 (Appendix A), indicating the habitat is partially supporting its designated use. The stream was approximately 6 feet wide and characterized mostly by a series of mostly riffles (Figures 12 and 13). Flow occupied >75% of the stream channel. Embeddedness was suboptimal with approximately 25 to 50% of the substrate particles surrounded by fine sediment. The coloration of the water was clear but there was evidence of moderate deposition of sediment within the streambed. The stream banks were stable and with good riparian areas.
